## Zeeman Shroud-Electrode Upgrade Kit for the GTA 120 Instruction Sheet

The Zeeman Shroud-Electrode upgrade kit extends the tube lifetimes in GTA 120Z instruments. The kit includes:

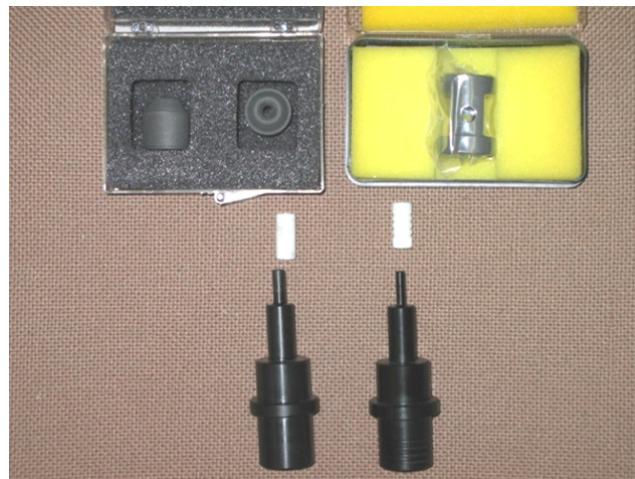
**Figure 1.** Kit contents: The 5 mm alignment checking tool is shown in the bottom left; and the 4 mm alignment checking tool (with grooves on the black probe and white spacer) is shown in the bottom right

- Alignment checking tool, 5 mm
- Alignment checking tool, 4 mm\*
- Zeeman pyro-coated shroud
- Zeeman narrow bore electrodes
- Instruction sheet.

\*The 4 mm alignment tool can be distinguished by four grooves on the probe and spacer.

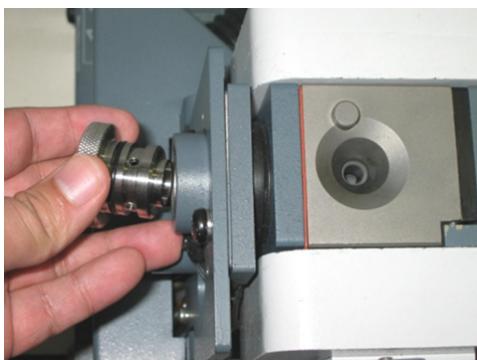
**Figure 2.** Removing an end window

- 1 Remove the work head from the instrument and place it on a bench.
- 2 Remove the two end windows from the workhead (refer to Figure 2).

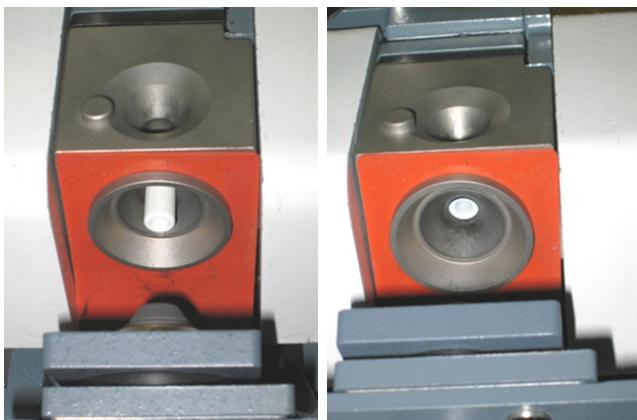
**Figure 3.** Inserting the spacer into the shroud

- 3 Insert the spacer into the shroud. Use the 5 mm alignment checking tool for workheads fitted with wide bore electrodes. Use the 4 mm tool for workheads with narrow bore electrodes (refer to Figure 3).

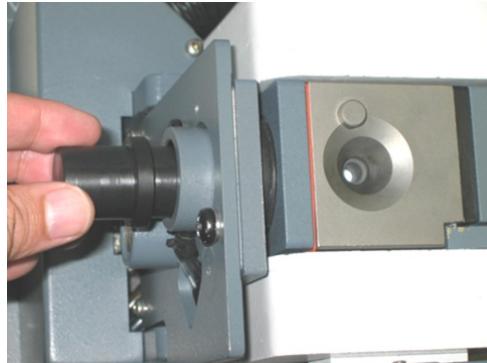
**Figure 4.** Inserting the probe to check workhead alignment

- 5** Insert the probe through the electrode holder as far as possible (refer to Figures 4 and 5). Do not force the probe. If the rim of the probe is not reached, the workhead has poor alignment (refer to Figure 6).

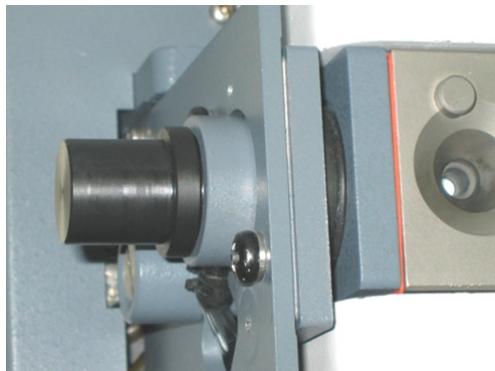
**Figure 5.** Workhead with good alignment

Replace the shroud and electrodes with those supplied in the upgrade kit. Use the shroud removal tool and electrode extractor tool.

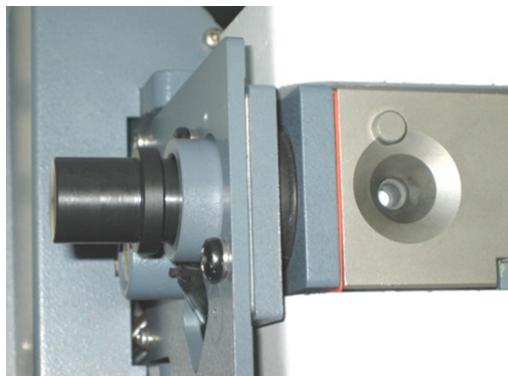
**Figure 6.** Workhead with poor alignment

Order a replacement workhead, as it cannot be re-aligned. The replacement workhead will have the new shroud and electrodes factory-fitted so you do not have to install the upgrade kit. Once you have received the replacement, return the faulty workhead.

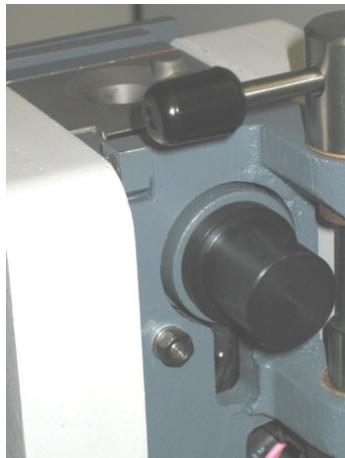
**Figure 7.** Opposite side of the workhead

- 6** Repeat Step 5 for the other side of the workhead (see Figure 7).
